Situation Photo Log

Thursday, February 14, 2013

Kalamazoo River / Enbridge Spill

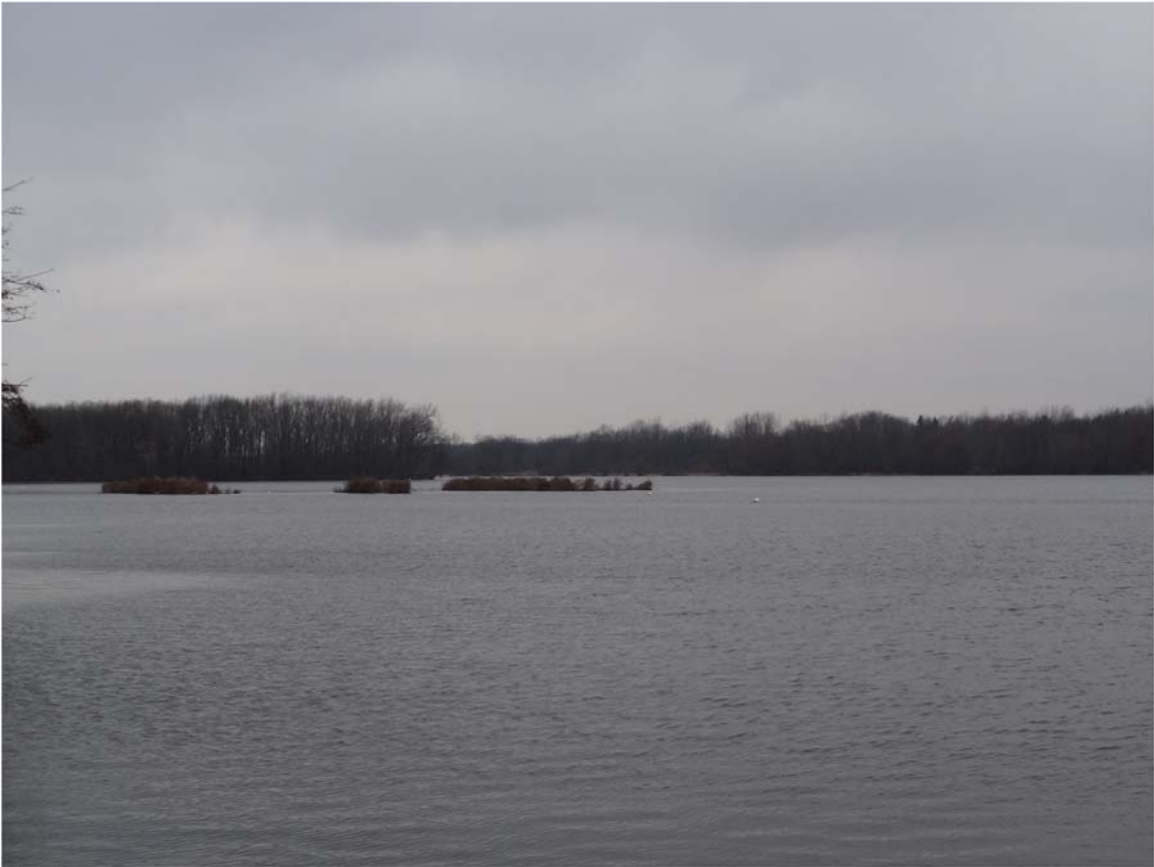
25. Morrow Lake Delta icing conditions.

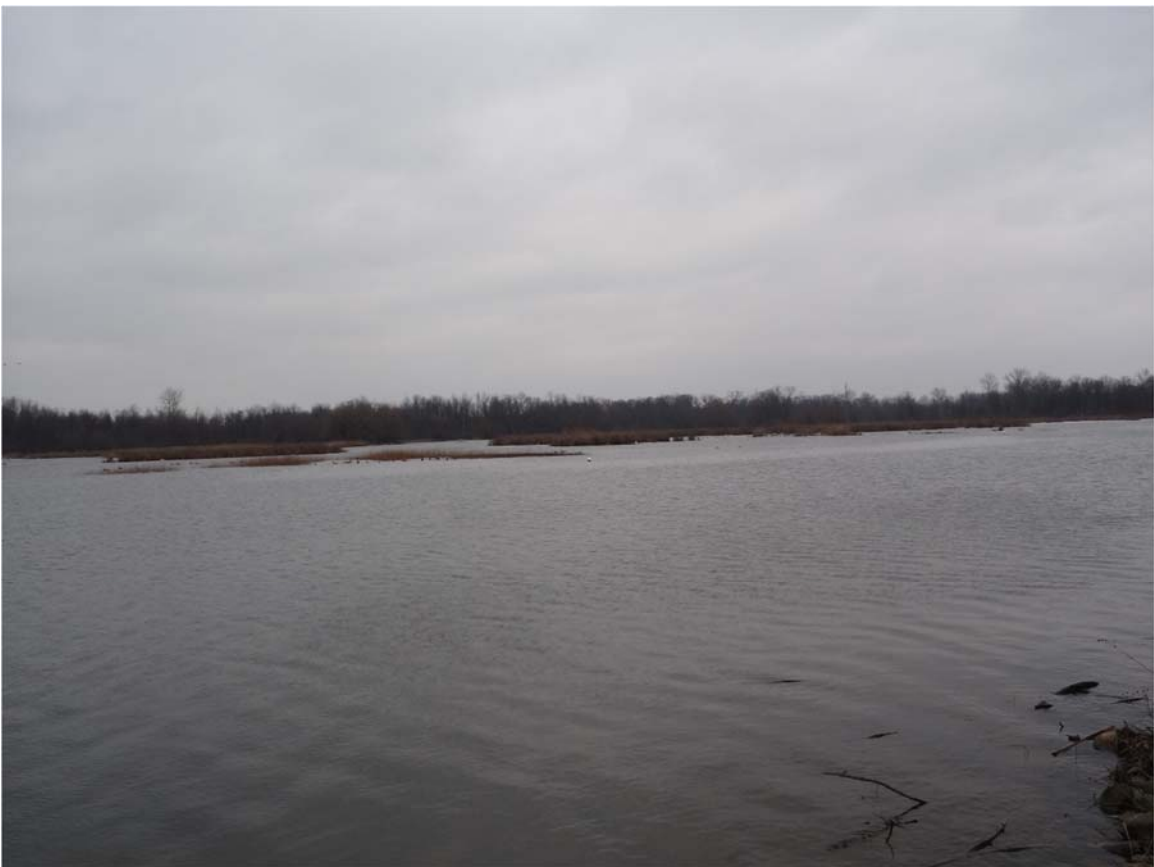
26. Morrow Lake Delta icing conditions.
